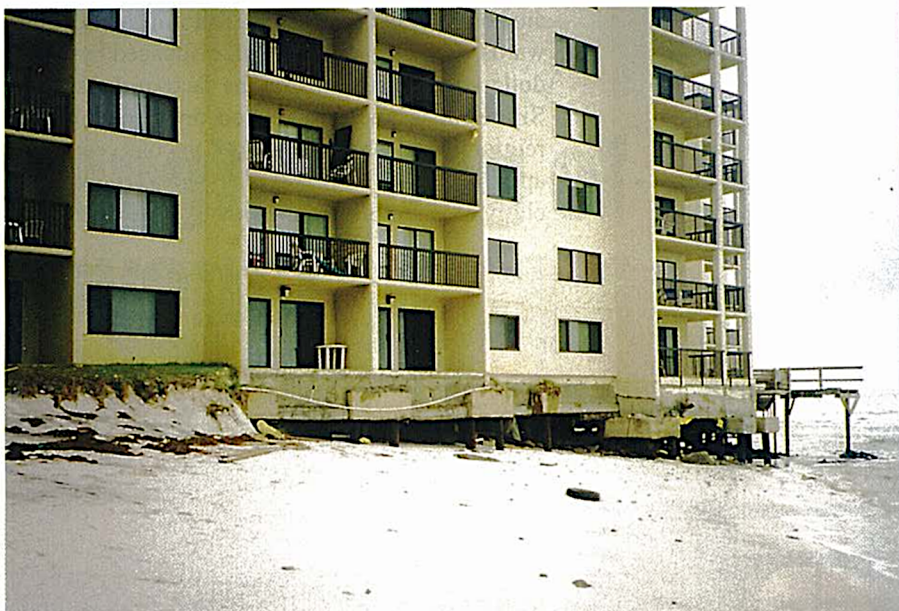
Figure 3: After Hurricane Georges, the turned down beams on the edge of the first floor slabs closed the gap between pile caps and saved the slabs on grade from collapsing

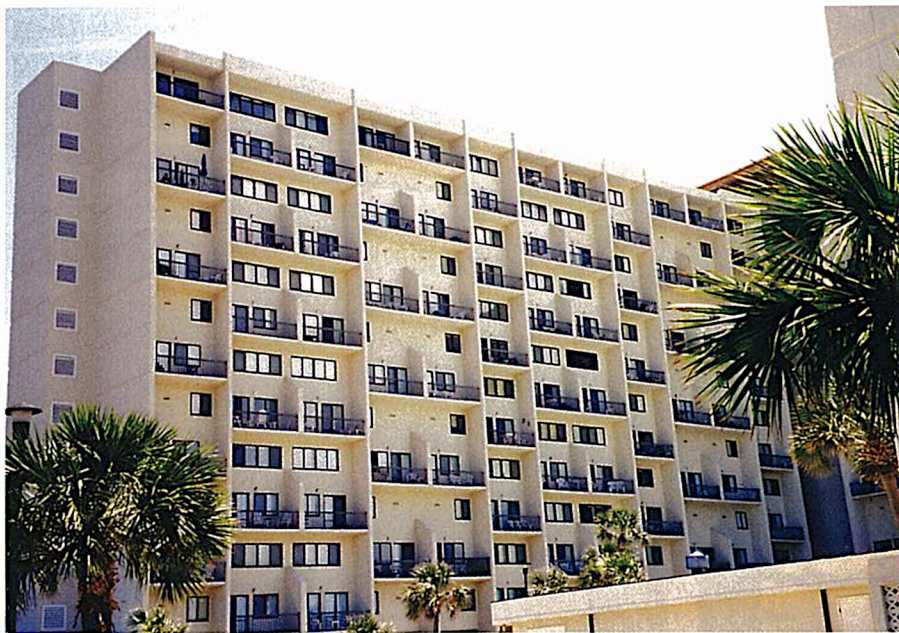
Figure 4: Completed project
