## Longevity Category

# Pinnacle Port Restoration

Panama City Beach, Florida

Submitted by Building Technology Consultants, Inc.

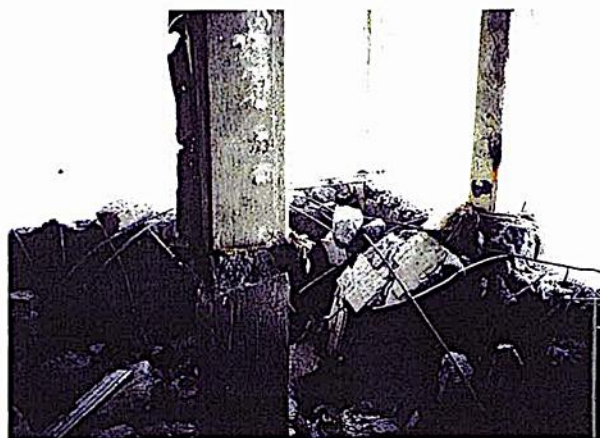
Shortly after the repair contractor had completed mobilization on the initial repair project, Hurricane Erin hit, causing additional damage on each of the seven buildings within the complex, including destruction of the contractor's stages. Rains saturated the open areas of concrete with chloride-laden sand and seawater. Sixty days later, just as the concrete restoration got back into full swing, Hurricane Opal made landfall, with a record tidal surge that caused the ground floor slabs to collapse

Figure 1: One of the "too tall" columns after Hurricane Opal and the remains of the first floor slab

As much of a surprise as these hurricanes were, bigger surprises were yet to come. This routine concrete repair job turned into an engineering and construction nightmare. The first big surprise came while investigating the collapsed ground floor slabs, when it became obvious that many of these small 8 x 16 in. concrete columns, originally designed to be only 8 ft high, were actually 12 to 15 ft high with no lateral support. After measuring and analyzing the as-built conditions, the engineers indicated there was no logical reason why the building was still standing.
