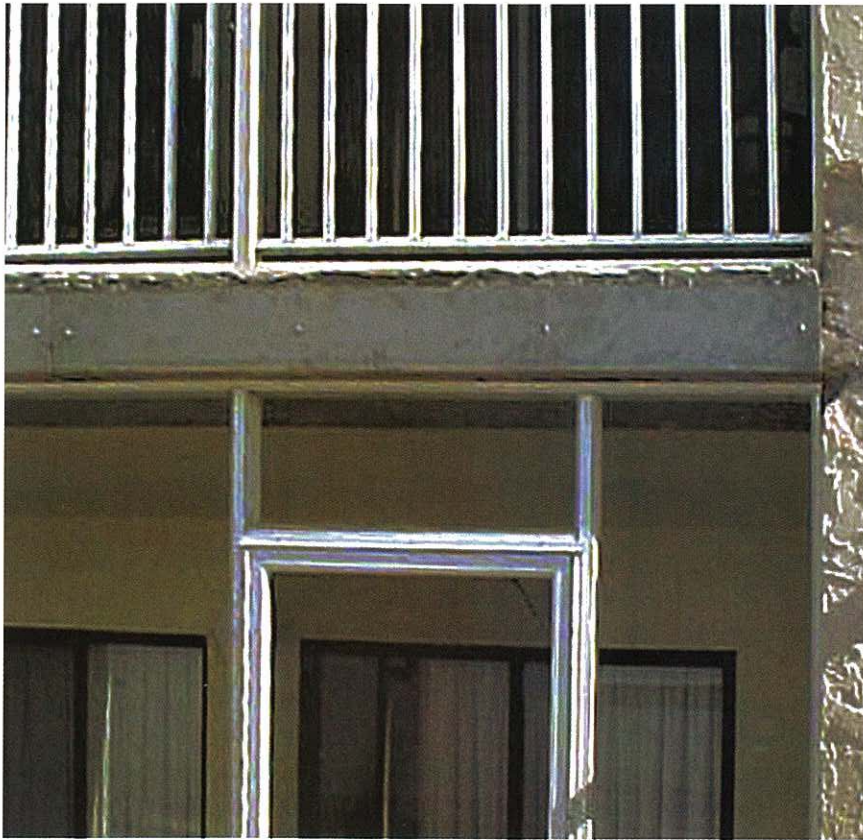
*During concrete restoration at Holiday Surf and Racquet Club.*

This method was one that had first been tried in 1989 in Mobile Shores, Alabama. In addition to adding to the structural integrity of the buildings, it had held up beautifully, promised to outlast any concrete patch remedy, and it looks good too! This method involved using stainless steel sheathing for end caps and extending interior structural reinforcements and anchoring it all to the existing healthy steel core and concrete structure along with the usual repair to balcony floors and adjoining walls, correcting the original structural defects and offering a solid, long lasting foundation to the cosmetic surface work.

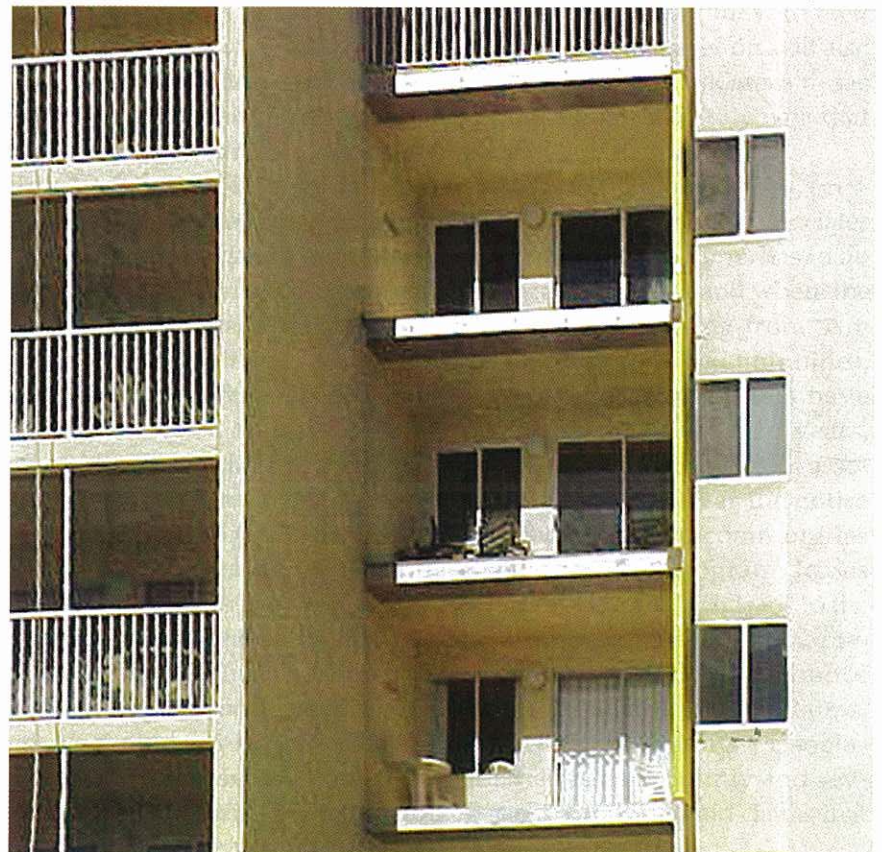
*After the work was completed.*
